FORCE MAJEURE NOTICE
ARECIBO MUNICIPAL LANDFILL
NOVEMBER 9, 2017

LANDFILL TECHNOLOGIES OF ARECIBO, LLC

RE: FORCE MAJEURE
UNITED STATES V. LANDFILL TECHNOLOGIES OF ARECIBO CORP.
CONSENT DECREE CIVIL NO. 3:14-CV-01438
DOJ CASE NO. 90-5-2-109629

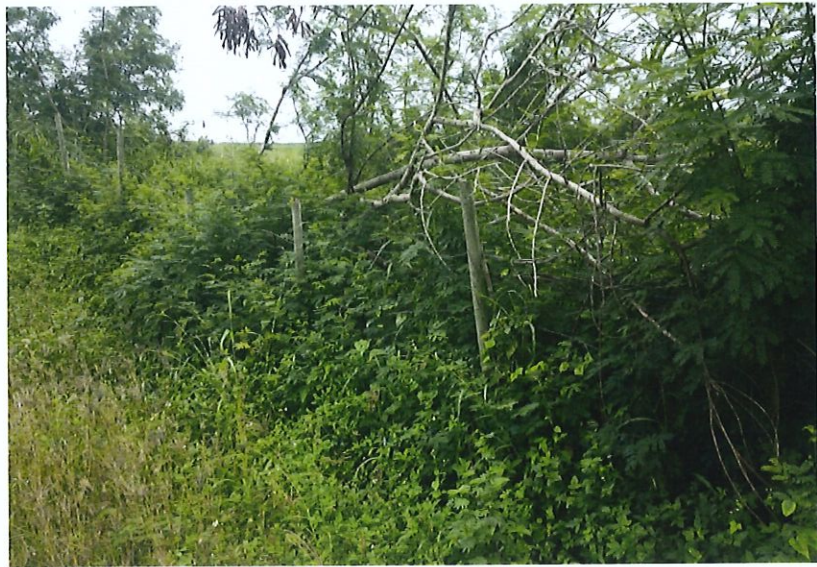
Photo No.: 1

Perimeter fence

Security: Continuous Maintenance of perimeter fences shall be delayed due to limited access for heavy equipment and due to the soil over saturation (see fence damage photos, Attachment I). The perimeter fence shall be repaired once the access is reestablished, LandTech Arecibo expects to complete the repairs within the next thirty (30) days.

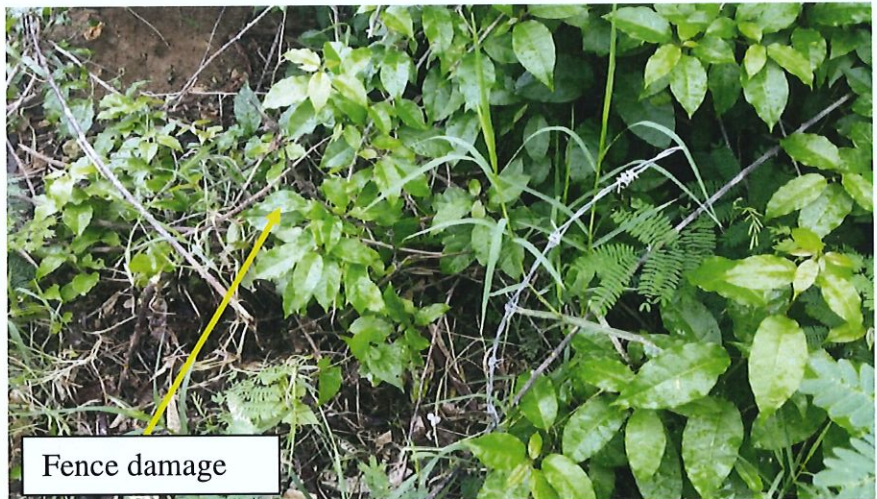
Photo No.: 2

Perimeter fence damage

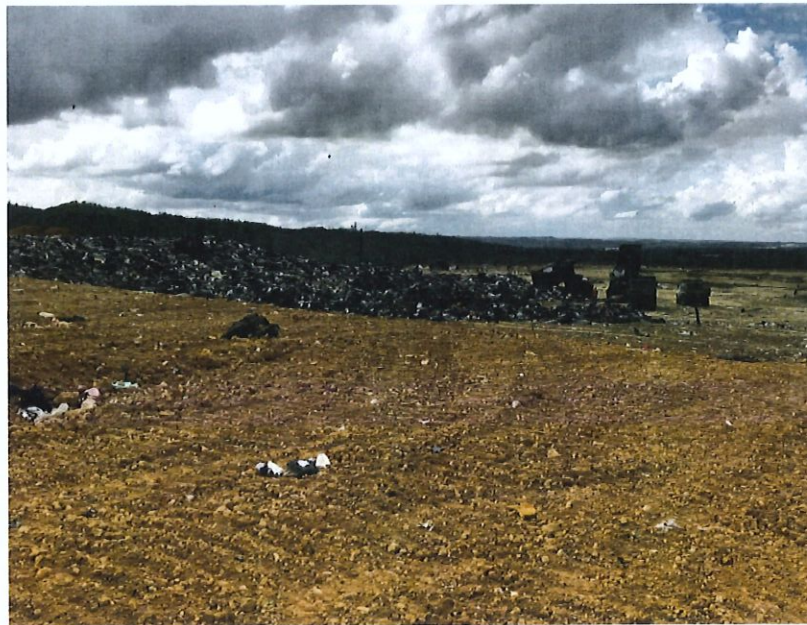
Photo No.: 1

Active cell

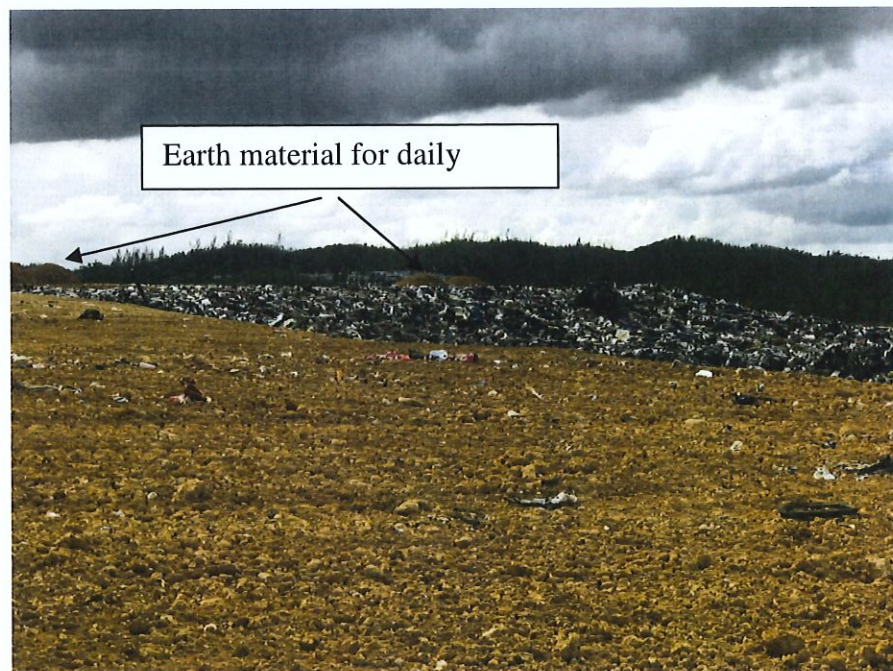
Photo No.: 2

Earth material available
for daily cover.

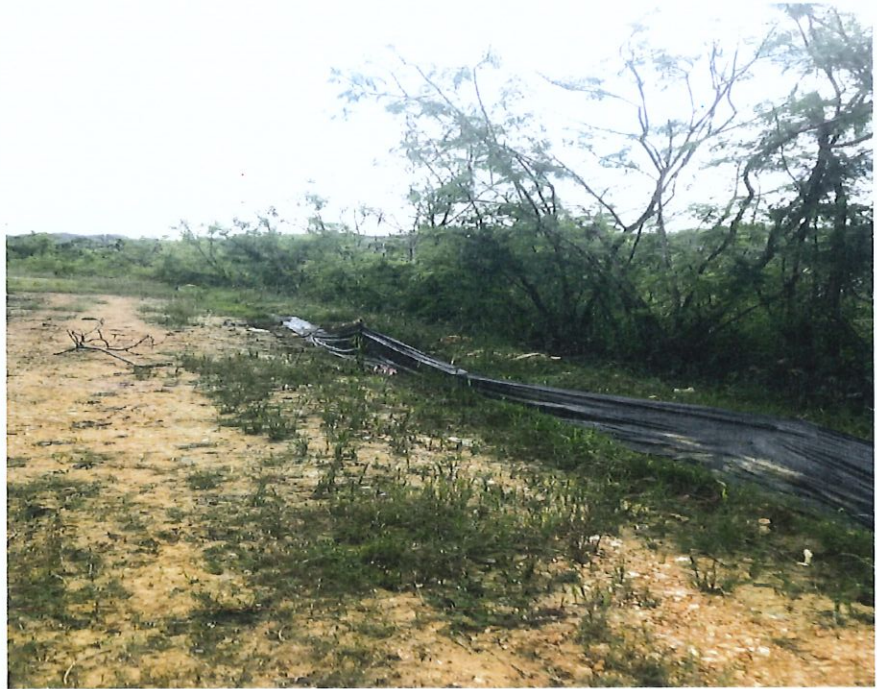
Photo No.: 1

Stormwater and Leachate Management: Excessive run-off from the Hurricane Maria extensive rains and subsequent precipitation events, damaged some components of the Stormwater Pollution Prevention Control System installed along to the boundary of the landfill, which were found to be severed and/or detached. LandTech Arecibo expects to fix this within sixty (60) days. Intermediate cover placed along the northern slope suffered erosion due to concentrated run-off from diversion berms failures. Saturated soil conditions of the perimeter have delayed the intermediate cover repair. LandTech Arecibo expects to start repairs within the next thirty (30) days, as we are currently experiencing an extended period of rain pursuant to a . Sedimentation components need replacement and/or cleaning; access road soil saturation has delayed this work. Land Tech Arecibo expects normal maintenance activities to resume within the next 30 days. At the Attachment III, you will find the photos of the Rain Event Log, silt fence damage, access road conditions and hay bales damage.

Silt fence damage

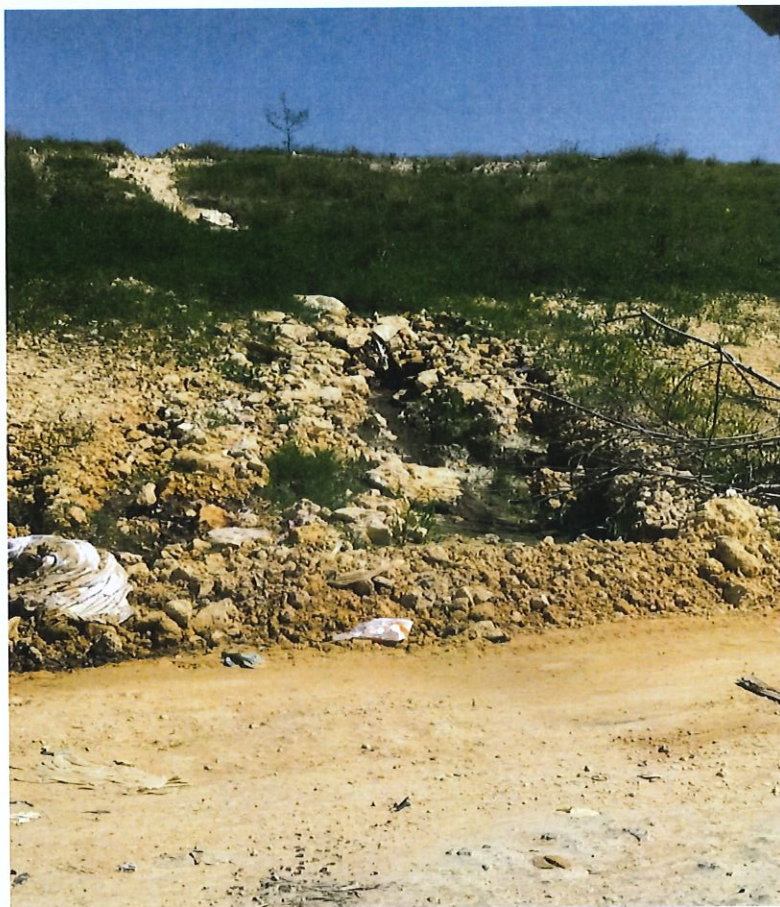
Photo No.: 2

As previously mentioned, along entire landfill perimeter side slopes, Hurricane Maria run-off has impacted the intermediate cover. This has produced increasing air intrusion into the deposited and covered waste mass and created some leachate seepages at the toe of the side slopes. Limited access by heavy equipment due to soil saturation has delayed LandTech Arecibo efforts to make the necessary repairs. These conditions will need further evaluation by LandTech Arecibo and assistance by EPA, as these repairs will negatively impact the financial condition of the Arecibo Landfill. As of today, Landtech Arecibo does not have an estimate for the repairs of the intermediate cover. Economically feasible alternative cover remedies are being evaluated. See photos of the side slope damage and impacted access road by leachate at the Attachment III.

Side slope damage
impacted by runoff.

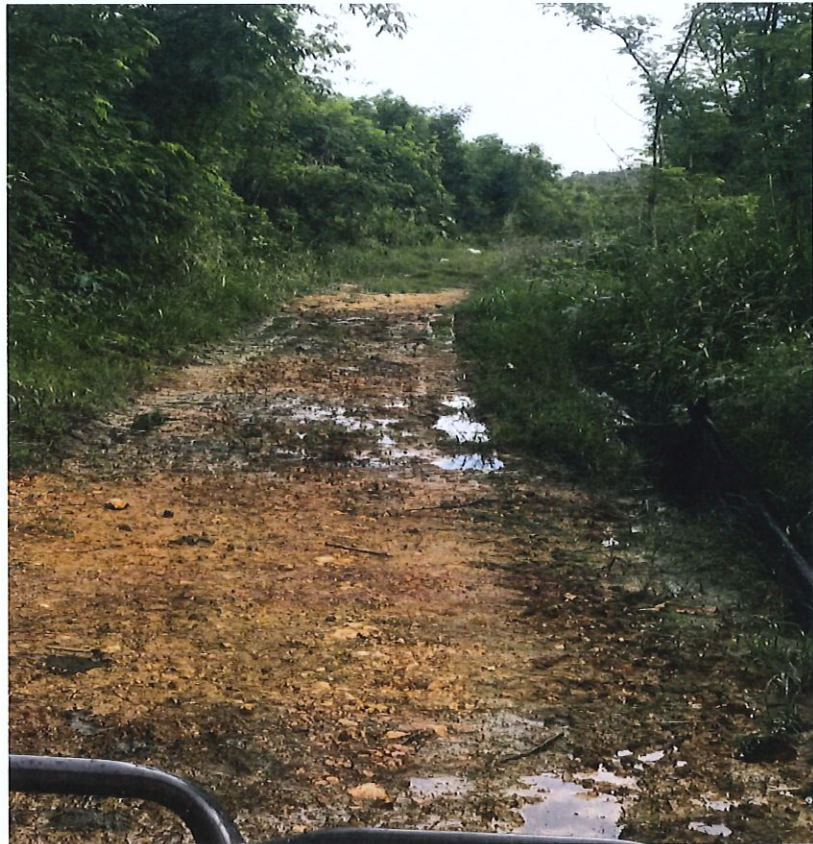
Photo No.: 3

Soil saturation by leachate
seepage.

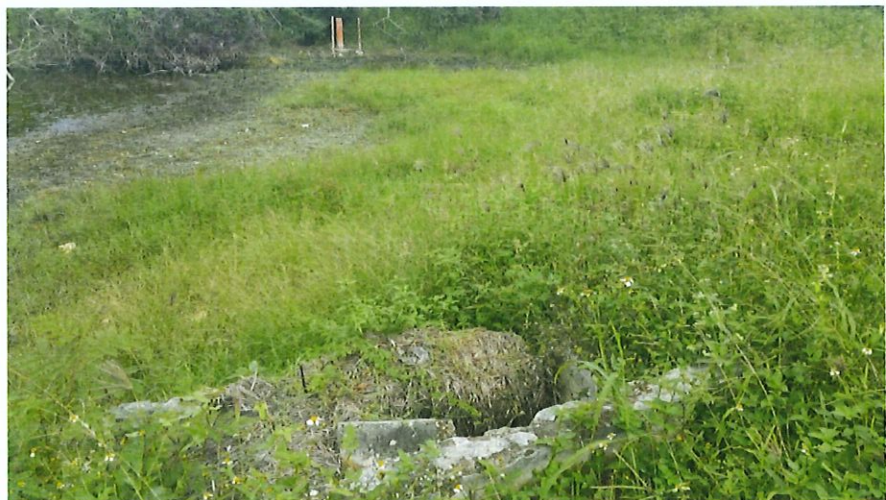
Photo No.: 4

Hay bale damage

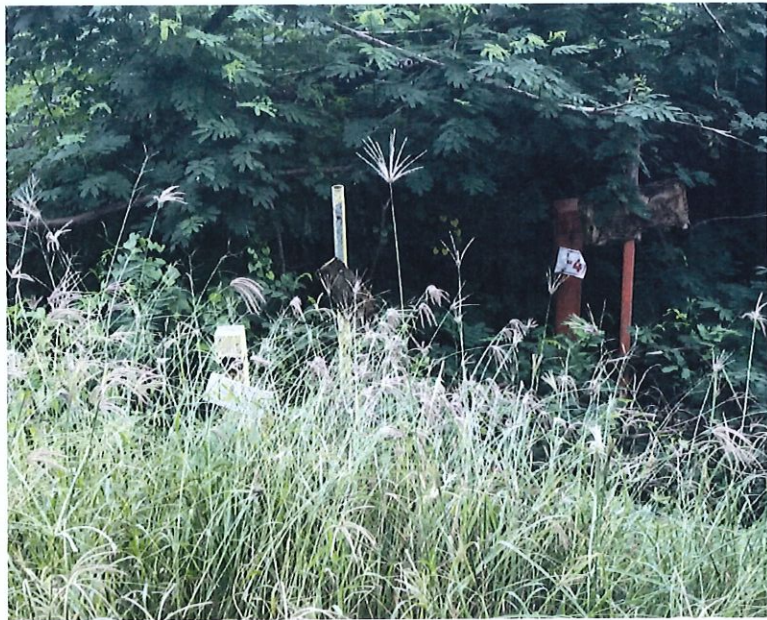
Photo No.: 1

Labeling of the
monitoring groundwater
wells were damage.

next forty-five (45) days to monitor well No. 2. The labeling of the monitoring groundwater wells were damaged, LandTech Arecibo expects to replace well labeling within the next forty-five (45) days. See Well #2 area photo at the Attachment IV.

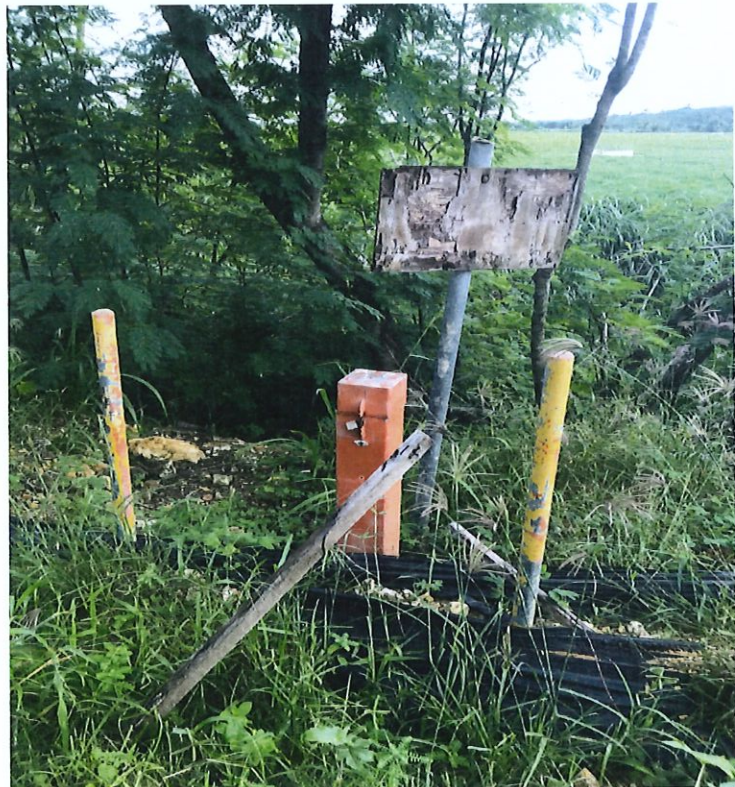
Photo No.: 2

Labeling of the
monitoring groundwater
wells were damage.

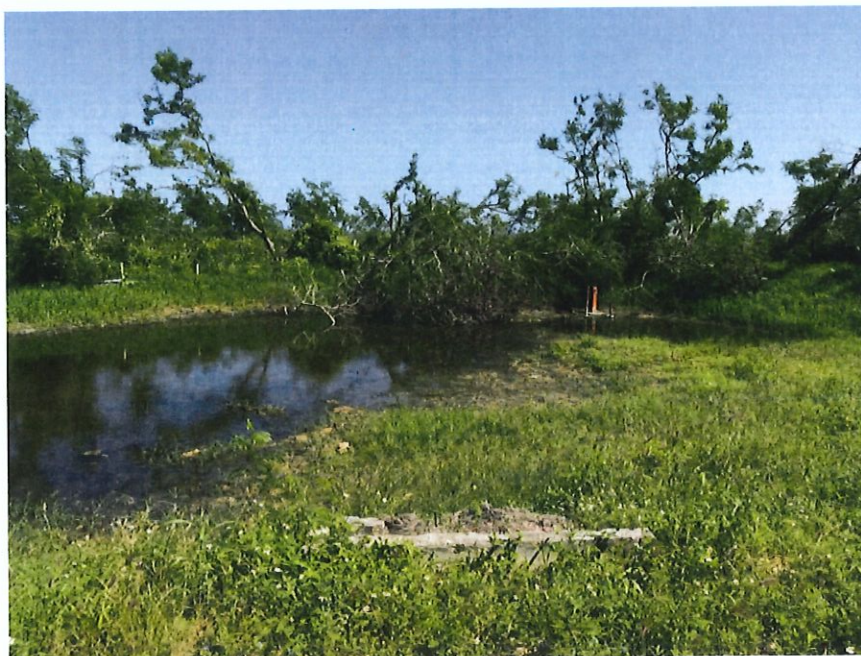
Photo No.: 3

Groundwater Monitoring: The Arecibo landfill has five (5) groundwater wells. In October, 2017, all the wells were monitored except the well No. 2 (W-2), which is located in a zone that was flooded due the rainfall associated to the Hurricane Maria. LTC expects to have adequate access to the well within the

During the groundwater monitoring event the well No. 2 (W-2) cannot be sampled, because the area was flooded.

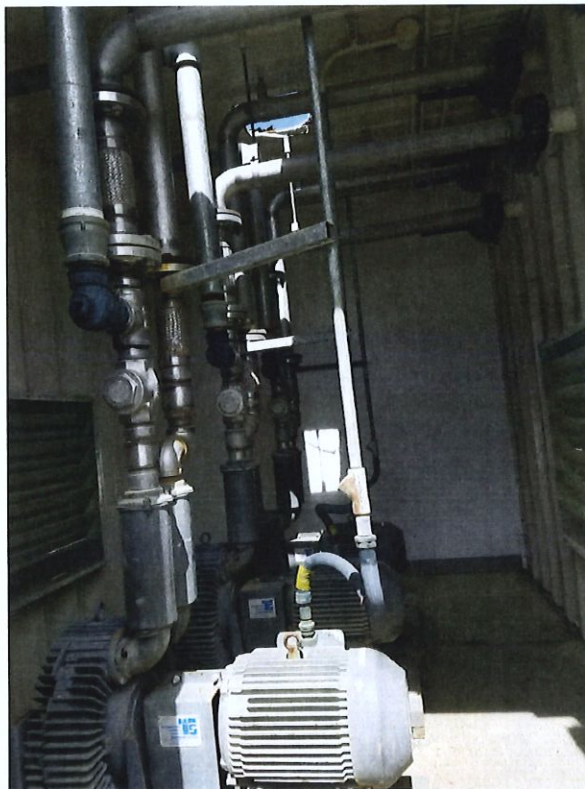
Photo No.: 1

Blower System (B-300)

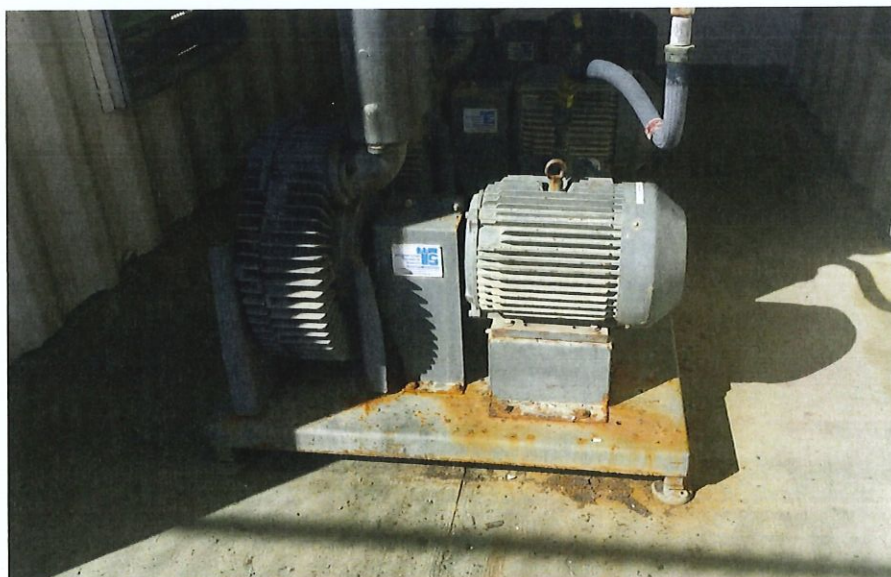
Photo No.: 2

The water intrusion
caused blower damage.

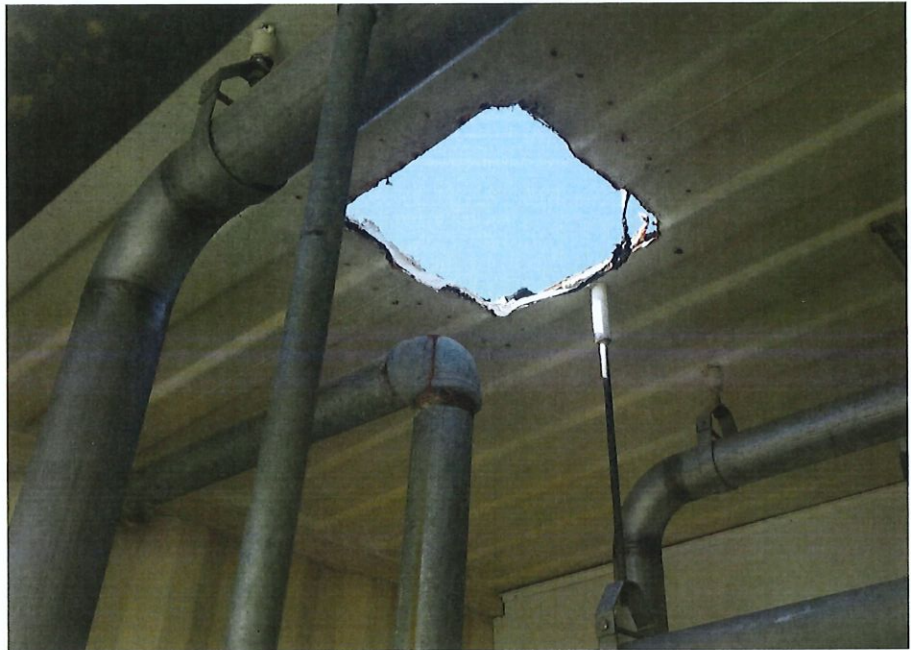
Photo No.: 3

Location of the extractor
at the trailer where are the
blower system.

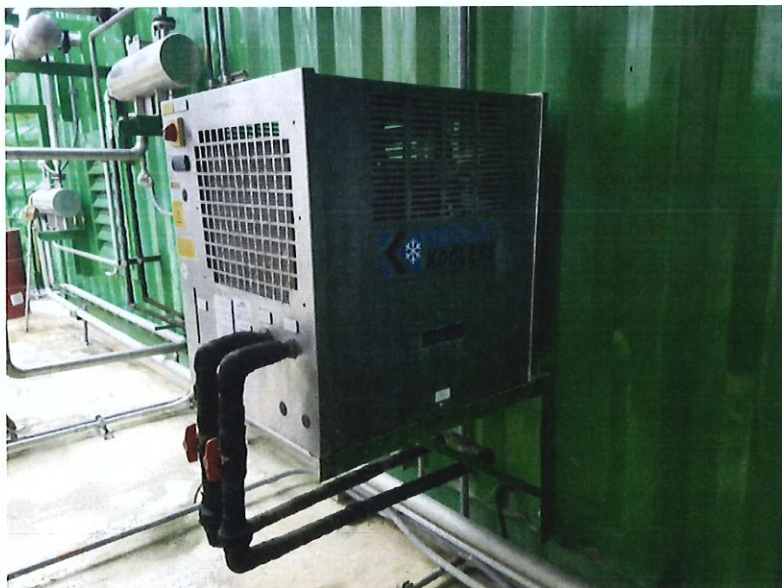
Photo No.: 4

The electricity of the
motor of the chiller system
of the GCCS was
damaged by the hurricane.

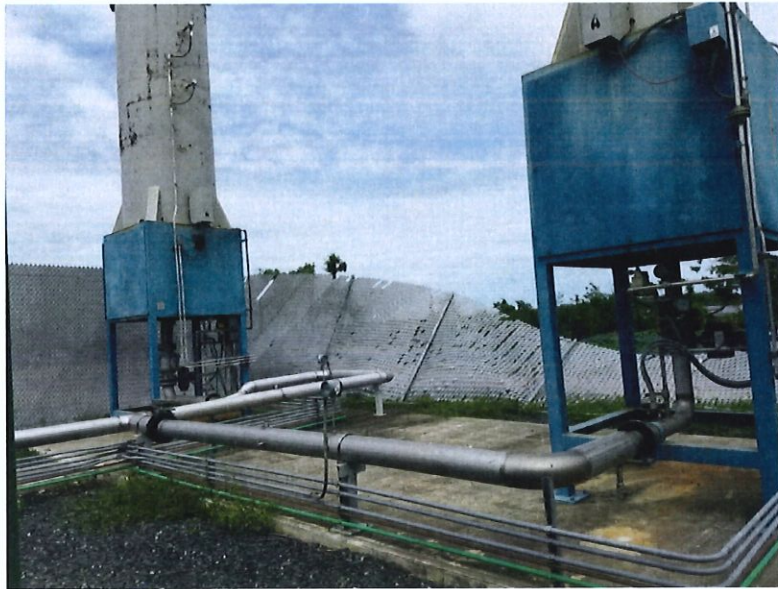
Photo No.: 5

Fence damage at the
GCCS area.

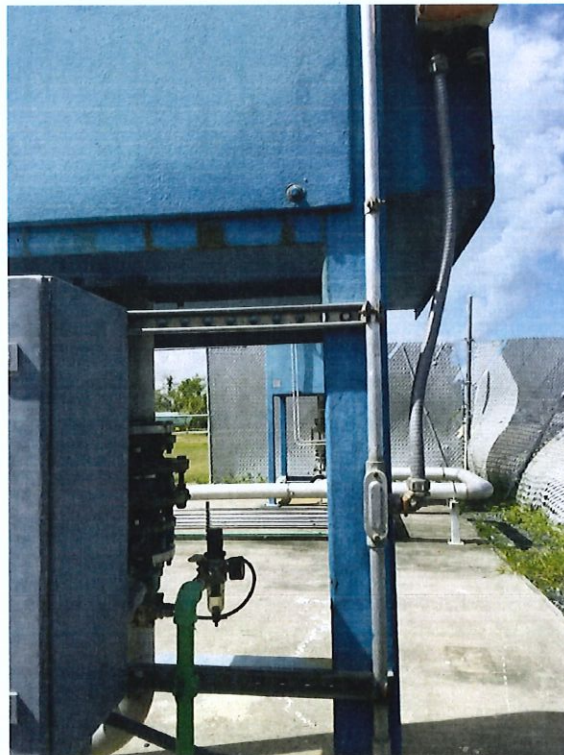
Photo No.: 6

Electrical System for the
instrumentation
(Thermocouples) of the
Flare with a capacity of 10
MMBtu/hr was damaged,
but was repaired.

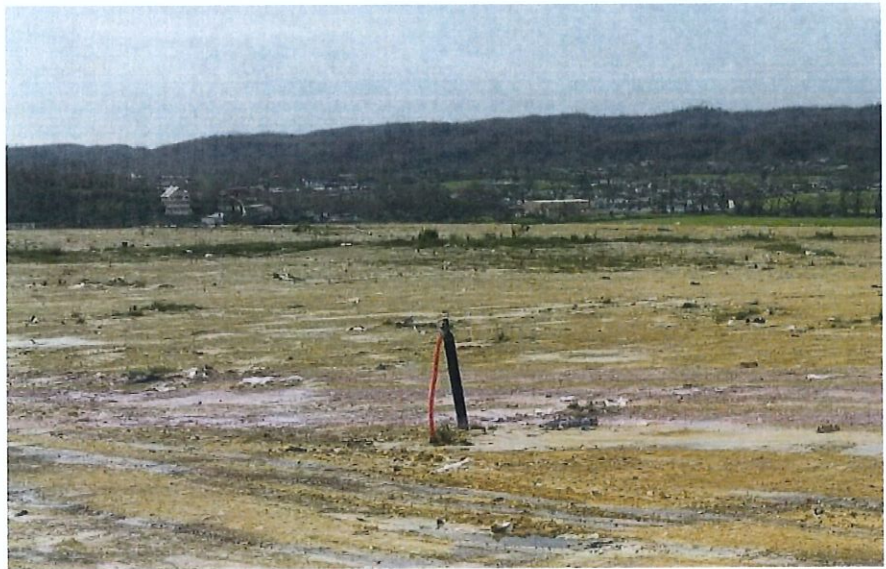
Photo No.: 7

Gas Collection and Control System (GCCS): Hurricane Maria winds and heavy rains impacted the GCCS' regular operations. Collection pipes, control equipment and wells were damaged by the winds and the intermediate cover suffered extensive erosion (see GCCS damage photos, Attachment V). The electric equipment protection system shut the system down on the September 20, 2017. As soon as the employees got access to the Landfill, GCCS recovery efforts began.

Several wells were
damaged and some pipes
were detached by the
winds during the
hurricane.

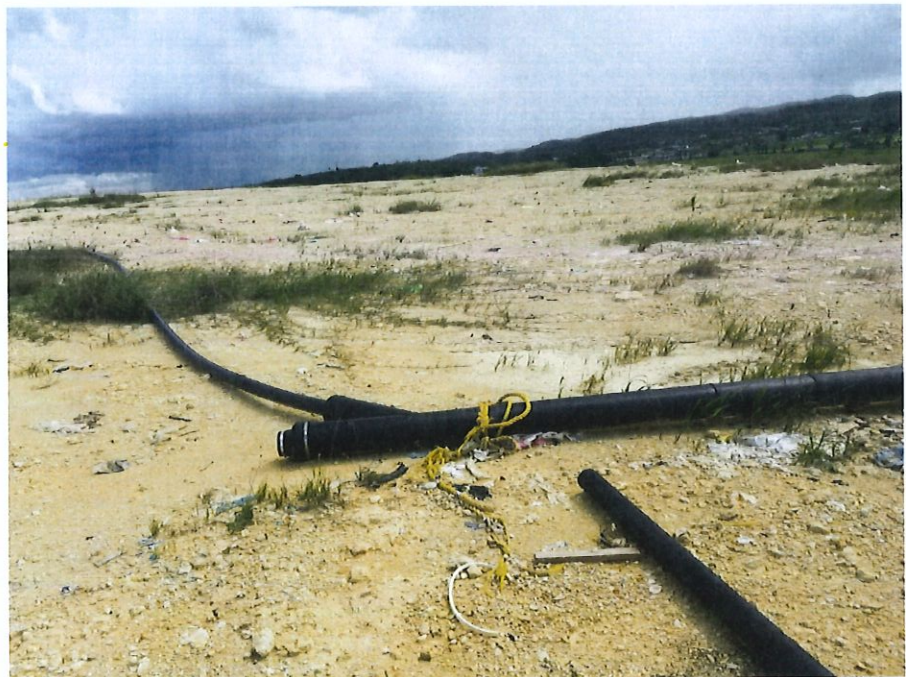
Photo No.: 8

The GCCS was successfully brought back online on October 20, 2017. Low methane concentrations and high oxygen intrusion caused by header, lateral and intermediate cover damages the system is the main reason why the GCCS is currently operating intermittently. Regular well condition monitoring shall resume once the GCCS operations is stabilized. Saturated soil condition at the side slopes and access roads, where the GCCS headers and laterals are located, have delayed the system repairs. LandTech Arecibo expects to get the system back to pre Hurricane Maria conditions within the next ninety (90) days, subject to the air infiltration effect on the perimeter wells.

Lateral pipes and header
of the GCCS were
detached by the winds
during the hurricane.

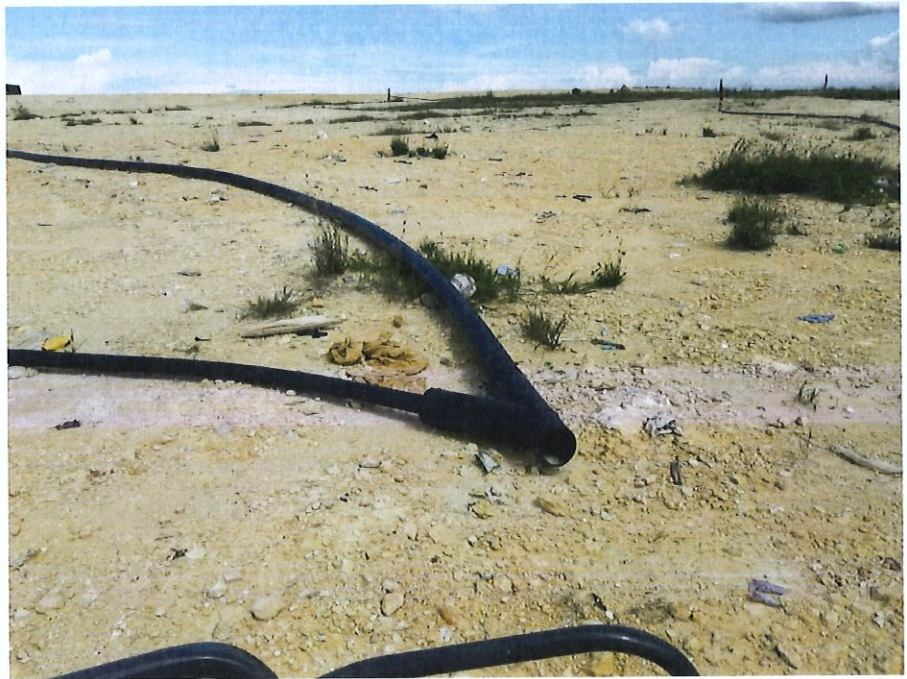
Photo No.: 9

Lateral pipes and header
of the GCCS were
detached by the winds
during the hurricane.
